Manhole Inspection Summary

Manhole # S41A2_015MH

Insp Date: **4/22/08 1:50 PM**

Location Address: **3737 Brooklyn Ave.**

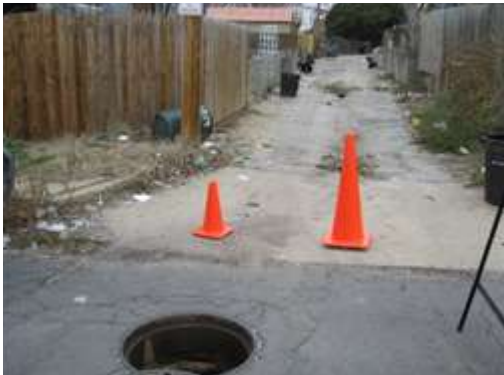
Location View

Garrett & Brooklyn-8th alley intersection

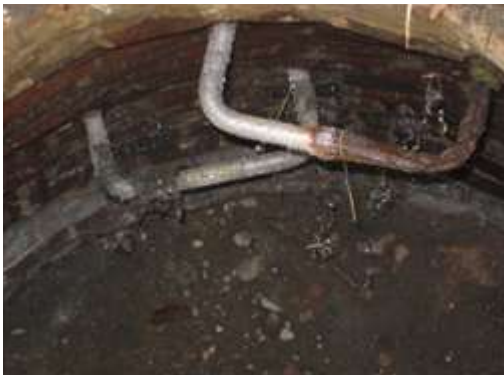
Count: **2** Missing: **0** ☒ **Corroded**

steps

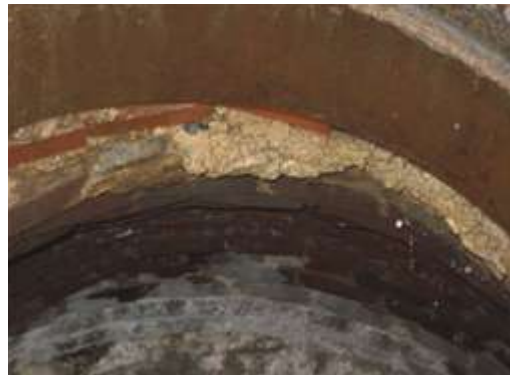
Defect 1

Condition: ☐ Sound ☒ **Cracked** ☐ Root Intrusion ☒ **Loose Brick** ☐ Deteriorated

Infiltration: ☐ None ☐ Joint ☐ Cracks ☐ Mortar ☐ Roots ☒ **Wall**

loose bricks on frame

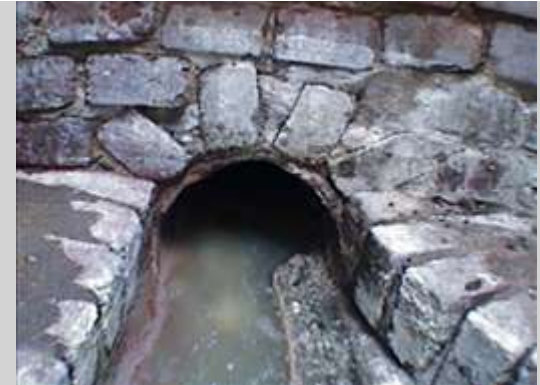
12 O'Clock Outflow

8 in. Circular Gravity Sewer
Pipe Out @ 12 O'Clock

Pipe Height: **9.6** (in.) Rod and Bar (Angled)
Pipe Material: **Clay** ☐ Pipe Lined
Invert Depth: **5.46** (ft.) Flow Characteristics: **Fast**
Deposits: ☒ None ☐ Mud ☐ Sludge ☐ Debris ☐ Grease
Silt Depth: (in.) Deposits Extent:
Infiltration: **None** Pipe Seal Cond: **Sound**

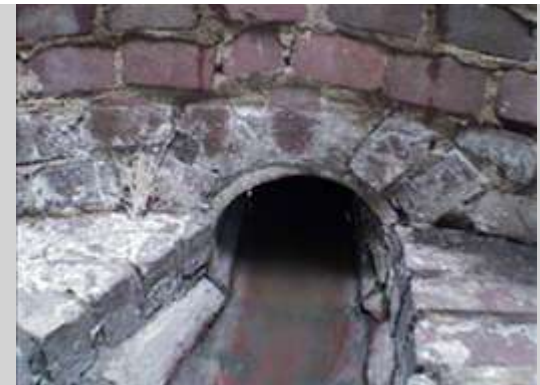
3 O'Clock Inflow

8 in. Circular Gravity Sewer
Pipe In @ 3 O'Clock

Pipe Height: **10.8** (in.) Rod and Bar (Angled)
Pipe Material: **Clay** ☐ Pipe Lined
Invert Depth: **5.39** (ft.) Flow Characteristics: **Fast**
Deposits: ☒ None ☐ Mud ☐ Sludge ☐ Debris ☐ Grease
Silt Depth: (in.) Deposits Extent:
Infiltration: **None** Pipe Seal Cond: **Sound**

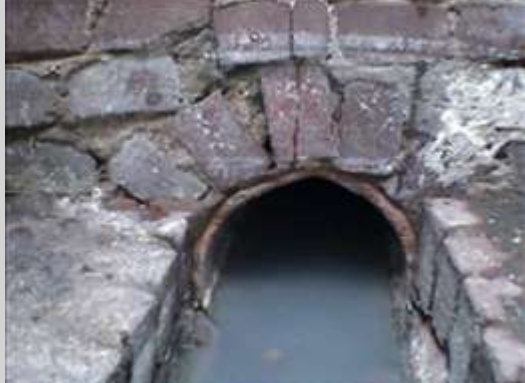
6 O'Clock Inflow

8 in. Circular Gravity Sewer

Pipe In @ 6 O'Clock

Pipe Height: **9.6** (in.) Rod and Bar (Angled)

Infiltration: **None** Pipe Seal Cond: **Sound**
